## Devil's Slide/Hwy 1 Storm Repair

Daily Updates from Bijan Sartipi

**Daily Update**  
May 24

Devil's Slide (post mile 39.14)

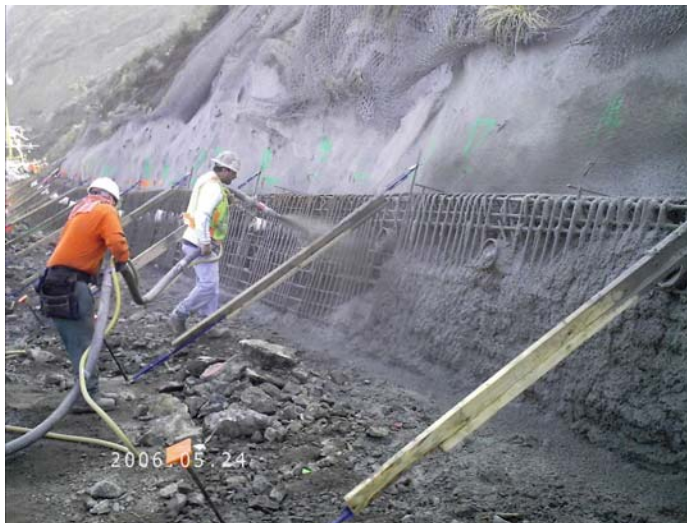
The start of concrete work on the first whaler wall

- 137 out of a total 257 rock dowels are now installed.
- Shotcreting the first bracing wall started to-day.

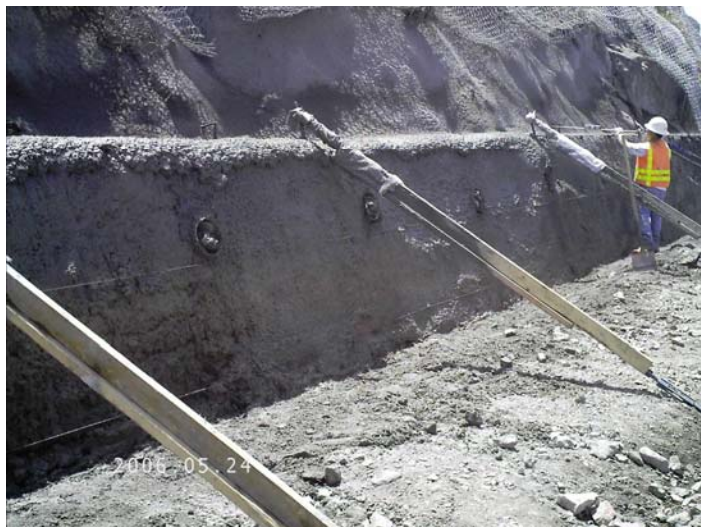
Starting to take shape after several truckloads of concrete

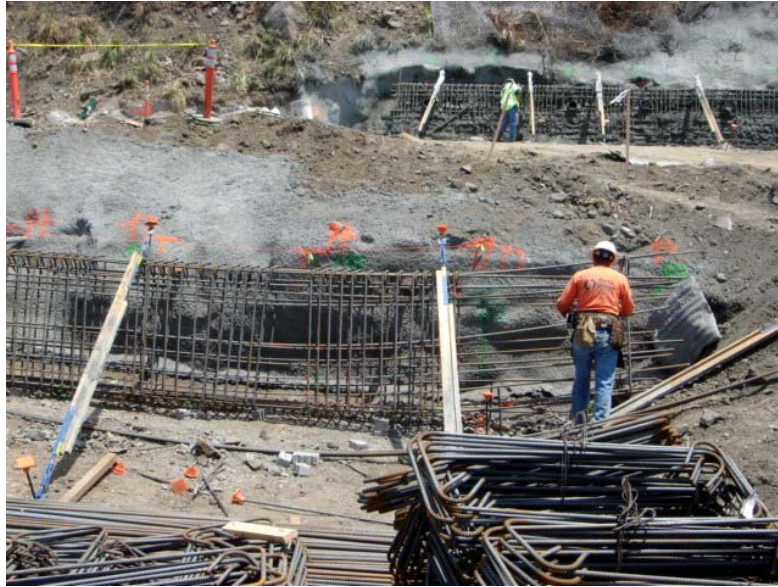
Beginning rebar work at the first of two whaler walls below the road.

- Rebar installation began to-day on one of the two bracing walls below the road.
